## GE 23 TON SWITCH ENGINE

### HISTORY

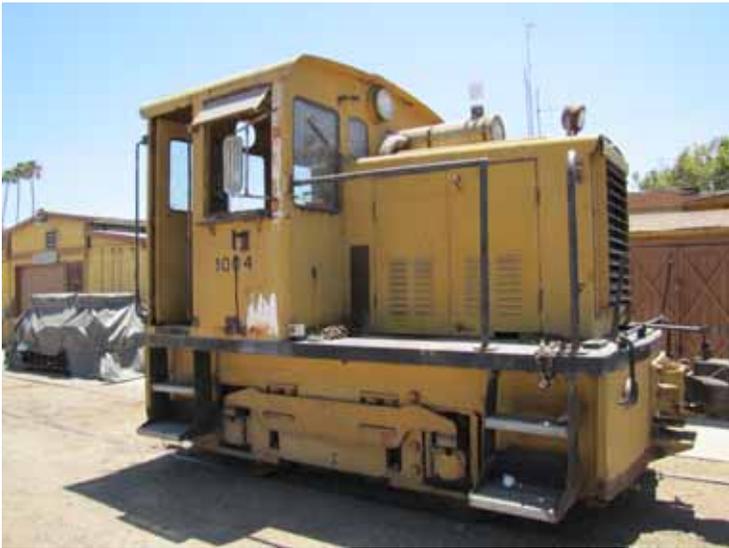
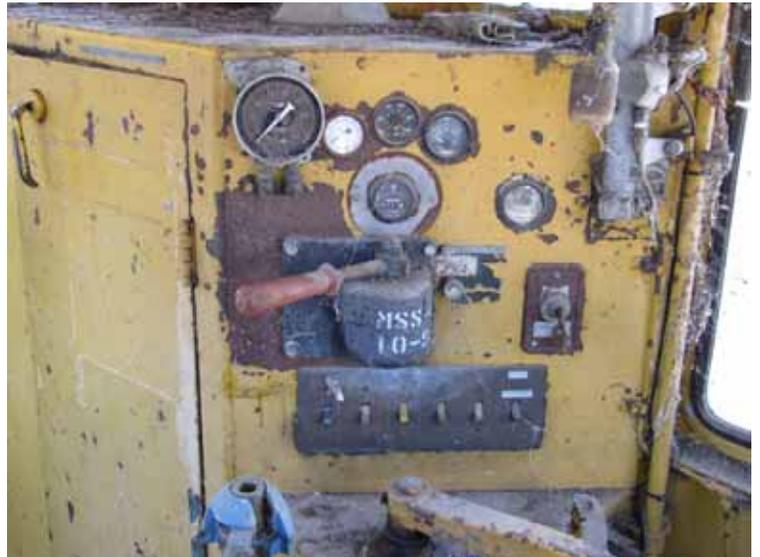
CONTROL PANEL

It sat up at the refinery for many years, and in 2016, the engine was donated to the Santa Clara River Valley Railroad Historical Society. Because it had been idle for so long, mud dauber wasps had taken up residence and turned the cab into a mess. The electrical and engine compartments were also a mess with cobwebs and dirt.

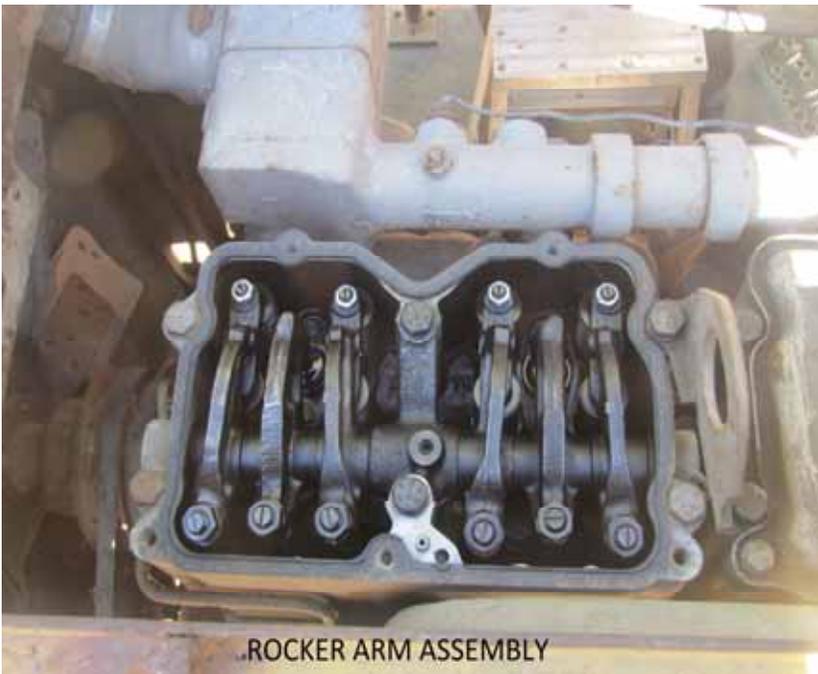
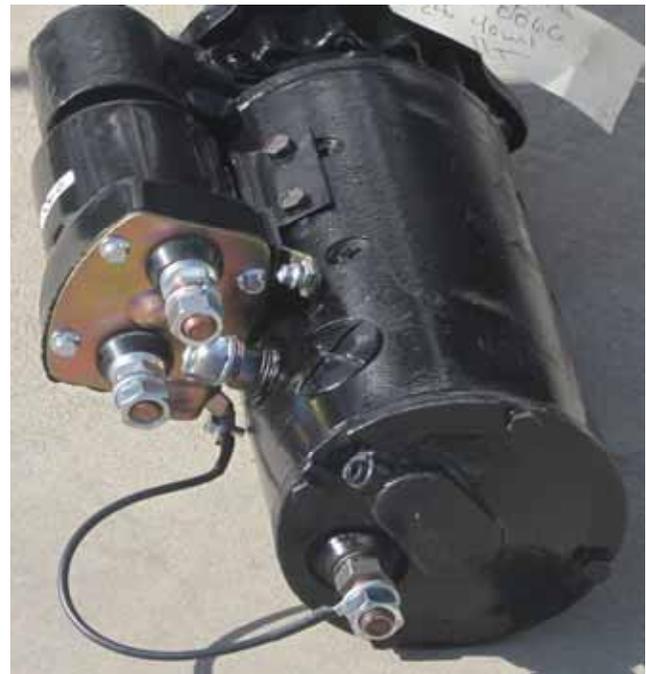
OVERHAULED STARTER

We removed the injectors and sent them to be cleaned and adjusted. We also poured some oil and transmission fluid into the cylinders to help loosen them. We also removed the starter and had it overhauled

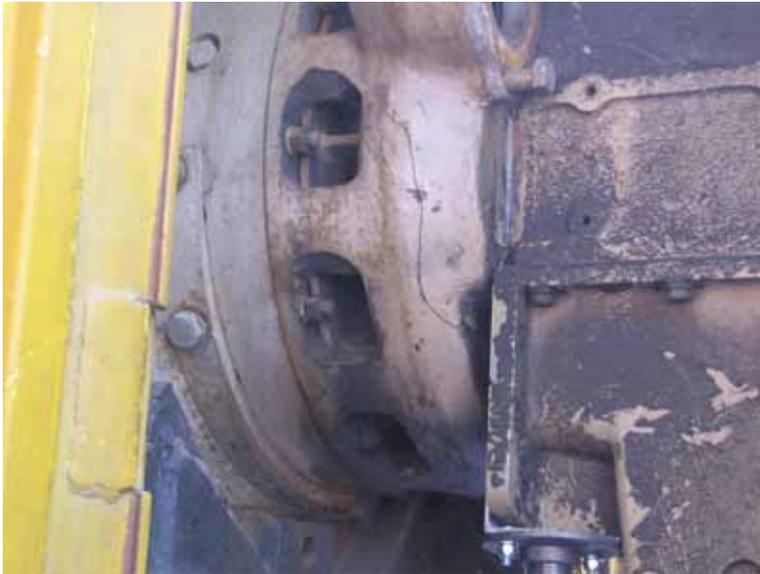
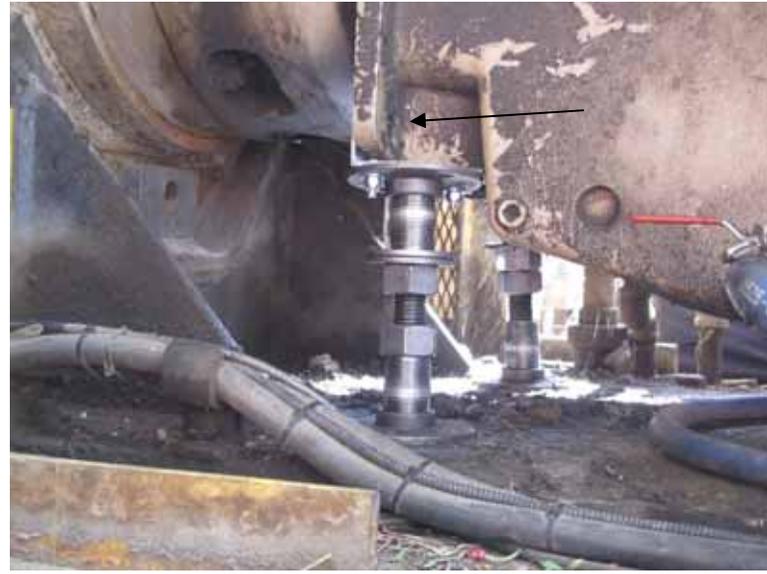
What we did was all well and good, but we had to face the biggest problem which was the cracked bell housing. Our analysis of the problem was that the diesel engine was supported at the front, but relied on the bell housing to provide support for the rear of the engine. The bell housing was cast iron,

and was not designed to handle that kind of stress, and eventually cracked on both sides, rendering the engine inoperable.

We also found a 9/16 inch hole in the back of the engine (arrow) to which we can bolt the brackets. We put a wrench on the back of the generator, and we were able to turn the engine. It did take a bit of effort, but we realized we were not only turning the engine crankshaft, but also the generator rotor!

We designed an adjustable support for the rear of the engine, and installed it temporarily for a fit check. The results were very encouraging, as the cracks in the bell housing closed up!

We finally got the right size bolts to bolt the brackets to the engine. Next time we work on the engine we will drill the brackets in place for a permanent installation.

The plan is to send the photos of the bell housing to Lock n Stitch to get a quote on them coming here and making a permanent fix.

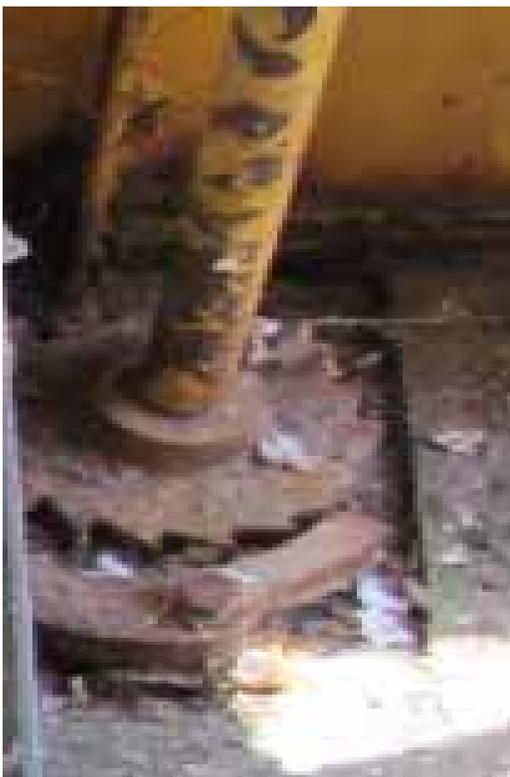
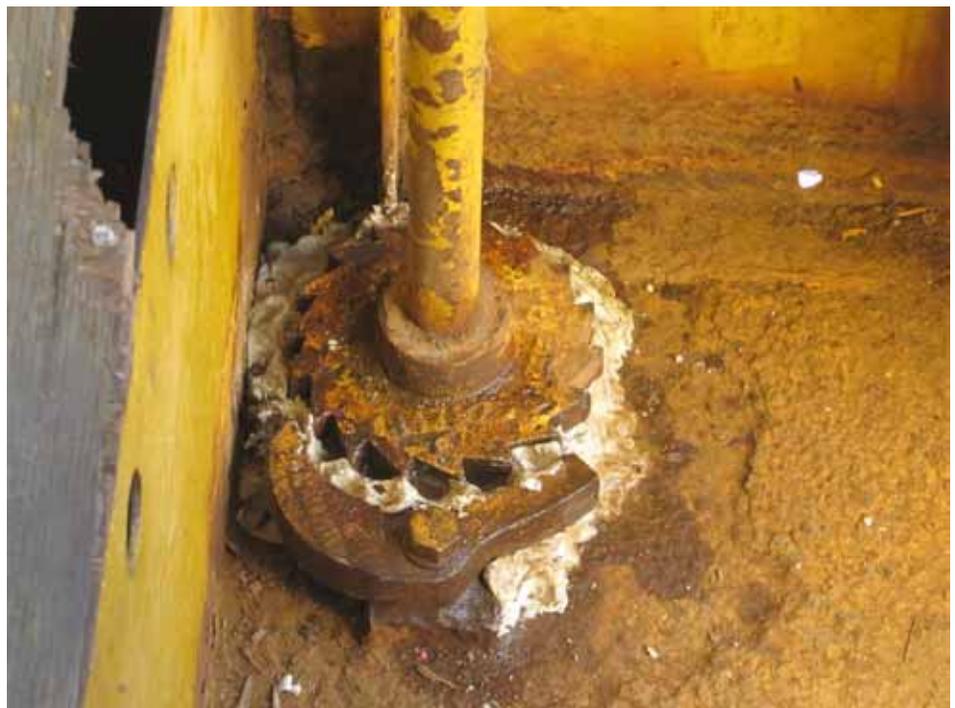
#### HAND BRAKE

In the meantime, we attended to another problem brought on by the inactivity of the engine and the close proximity to San Francisco Bay. The hand brake next to the battery box was frozen with rust. We moved the pawl and wire brushed the area around the gear. We then built a dam around the gear with plumber's putty and filled it with penetrating oil. We wire brushed the underside of the shaft and the plate holding the end of the shaft. We also applied penetrating oil at both places. Our plan is to let it soak for a while then try to move the hand brake. We will also try jacking the shaft from the bottom to break it loose. If all else fails, I have a 3 pound sledge to break it loose.
